FHWA/CA/ESC-98/02

Vehicular Crash Tests of a Slip-formed, Single Slope, Concrete Median Barrier

December 1997

Material Engineering and Testing Services
California Department of Transportation
5900 Folsom Blvd., PO Box 19128
Sacramento, Ca. 95819

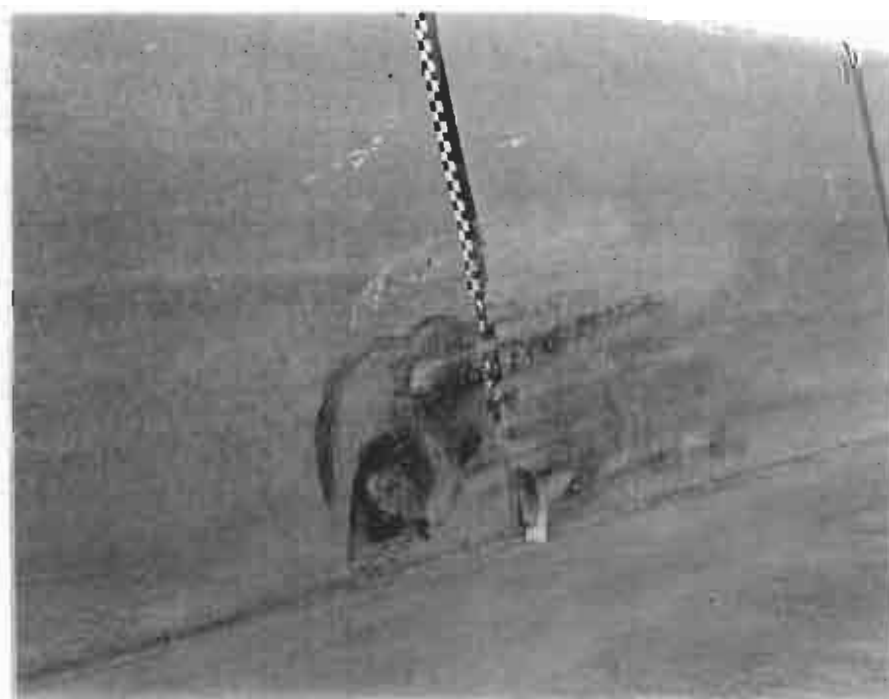
**Figure 2.15 - Test
531 Scuff Marks On
The Texas Barrier**

Barrier damage was cosmetic only, consisting of scrapes and tire marks. Both left tires left marks along the face of the barrier for the three to four meters of contact. Small amounts of concrete spalled from the face of the barrier where the vehicle's sheet metal made contact.

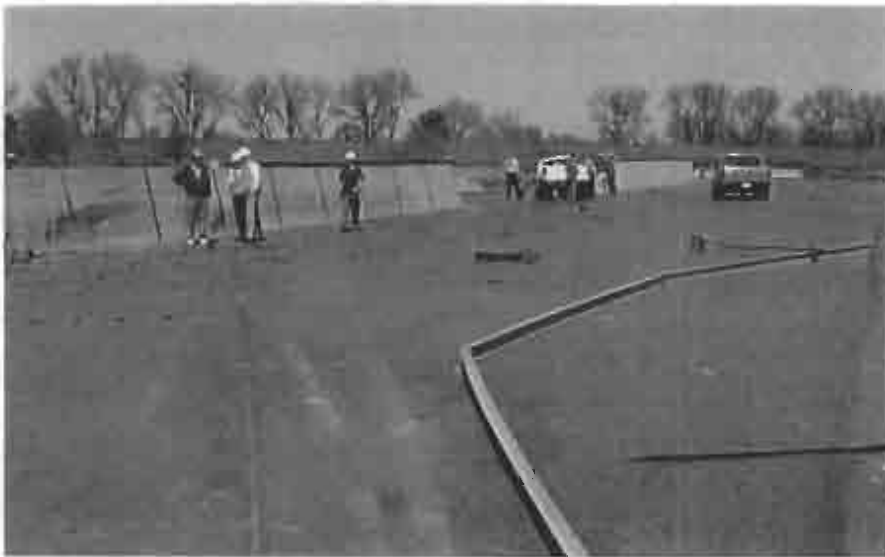
Due to problems with the guidance system the vehicle impacted at an angle and speed that were significantly different from the planned impact conditions. The vehicle's intended path to impact started with a 100 m straight section into a 100 m curved section (800 m radius turn to the left), and ended with a 50 m straight section into the barrier. About 150 m before impact, the vehicle's steering system began to oscillate and the vehicle started shifting from side to side. As the vehicle came out of the planned 800-m radius turn to the left, it appeared to be recovering from the side-to-side motion. However, the recovery was incomplete and the vehicle started to lose traction. The vehicle's rear tires skidded into the guidance rail, causing the rail to break loose. At 0.6 seconds before impact the guidance arm broke loose from both the guide rail and the vehicle. The emergency brake was applied 0.25 seconds before impact. The impact speed, angle of impact and yaw angle were 71.5 km/h, 53 degrees, and -19 degrees, respectively. Impact occurred 3 m upstream from the intended impact point.

**Figure 2.20 -
Broken Guidance
Rail And The Final
Impact Location For
Test 532**

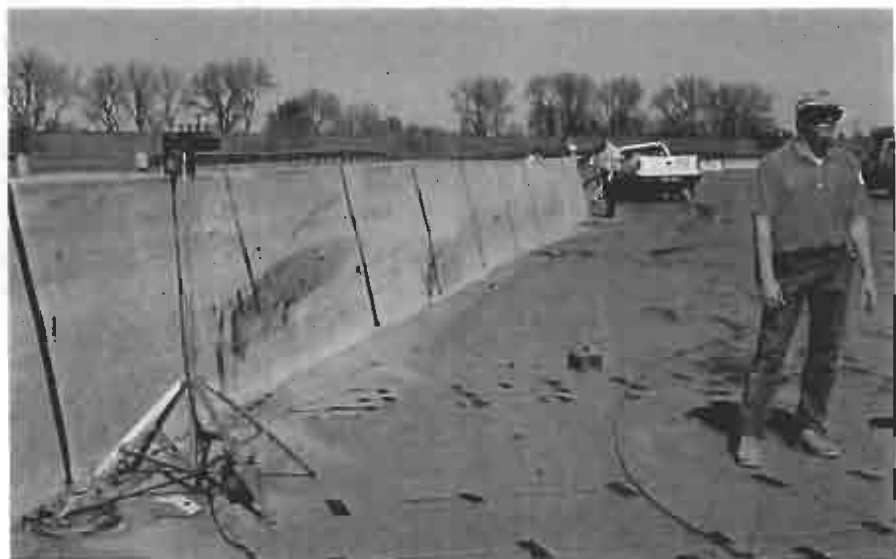
**Figure 2.21 - Test 532
Scuff Marks At The
Impact Location**

Barrier damage was cosmetic only, consisting of scrapes and tire marks. Small amounts of concrete spalled from the face of the barrier where the vehicle's sheet metal made contact.

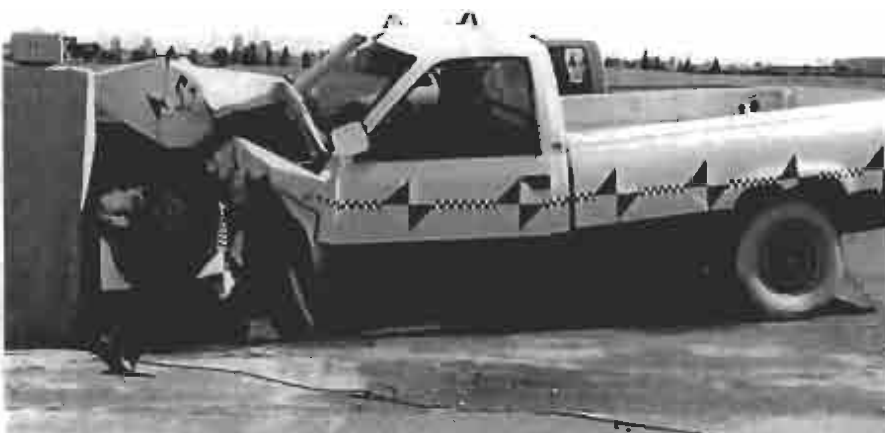
**Figure 2.22 - Test
532 Barrier Impact
On The Nose Of A
Second Barrier**

A large portion of the vehicle damage occurred after the initial impact when the vehicle ran into the blunt end of the Type 60G barrier which was being prepared for the next test and was just downstream from the Texas Barrier.

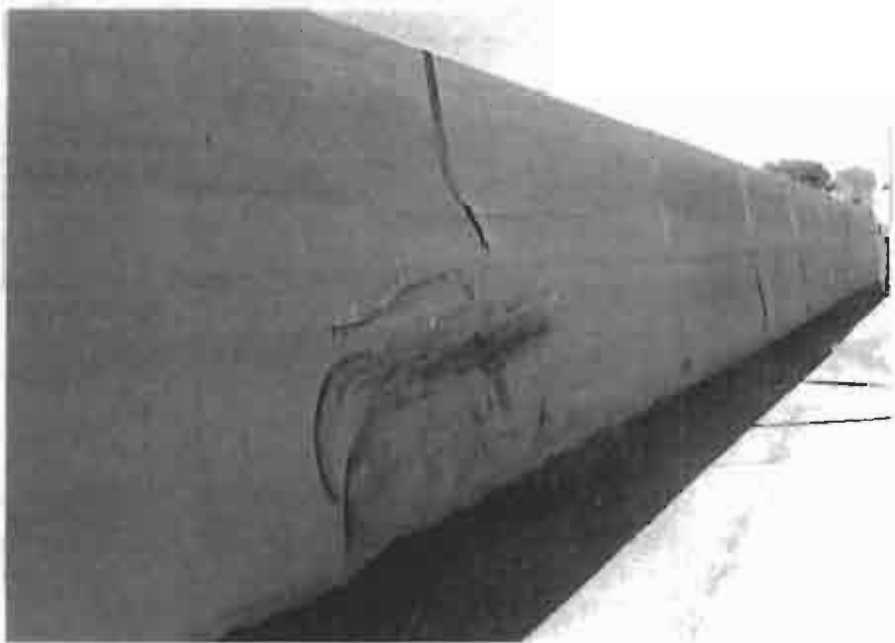
**Figure 2.27 - Test
533 Scuff Marks On
The 60G Barrier**

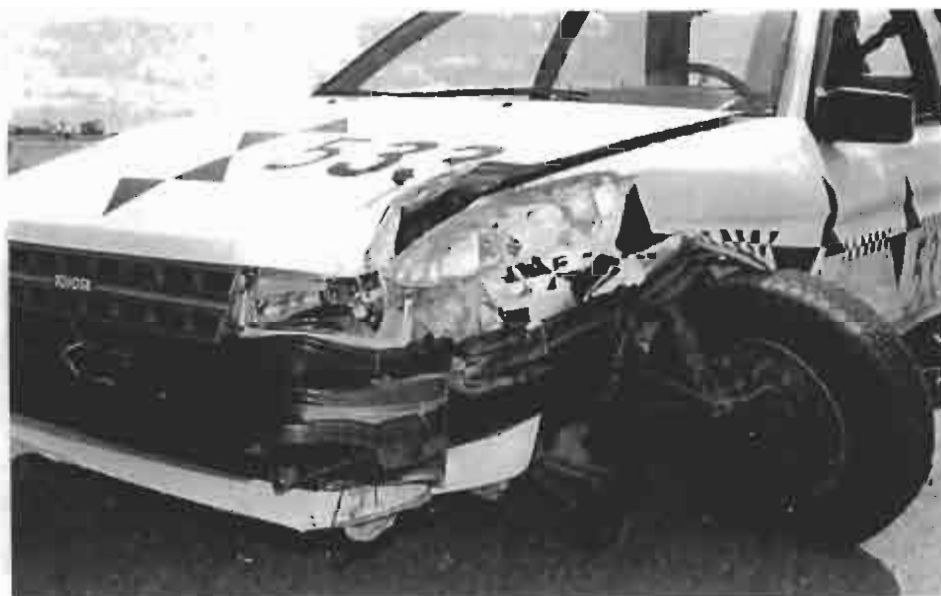
**Figure 2.28 - The
Front Left Of
Vehicle 533 And
The Damaged
Wheel Assembly**

The initial impact caused the bumper to turn inward toward the tire. The front left wheel assembly was torn from the suspension, leaving only the strut to hold the assembly onto the vehicle frame. Near the point of impact the hood was slightly crumpled.

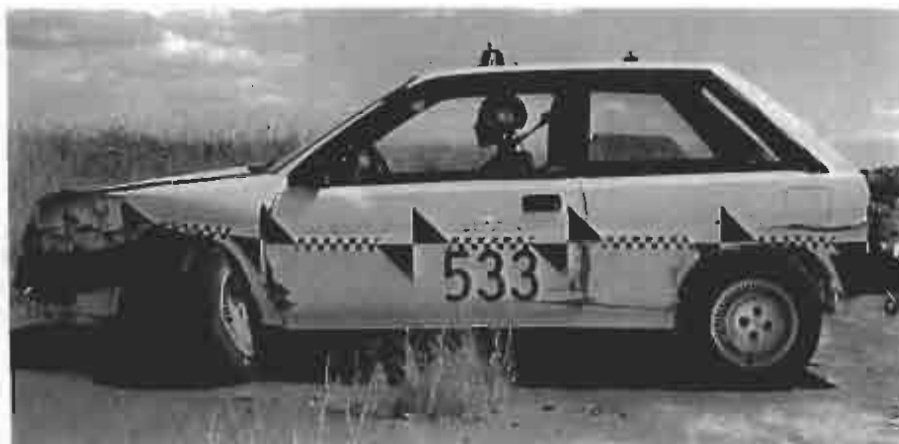
**Figure 2.29 - The
Left Side Of The
Damaged 533
Vehicle**

Damage to the vehicle was moderate, and nearly identical to the vehicle damage incurred in test 531. The front left corner of the vehicle sustained the majority of the damage. There was additional sheet metal crushing and scraping along the left side of the vehicle.

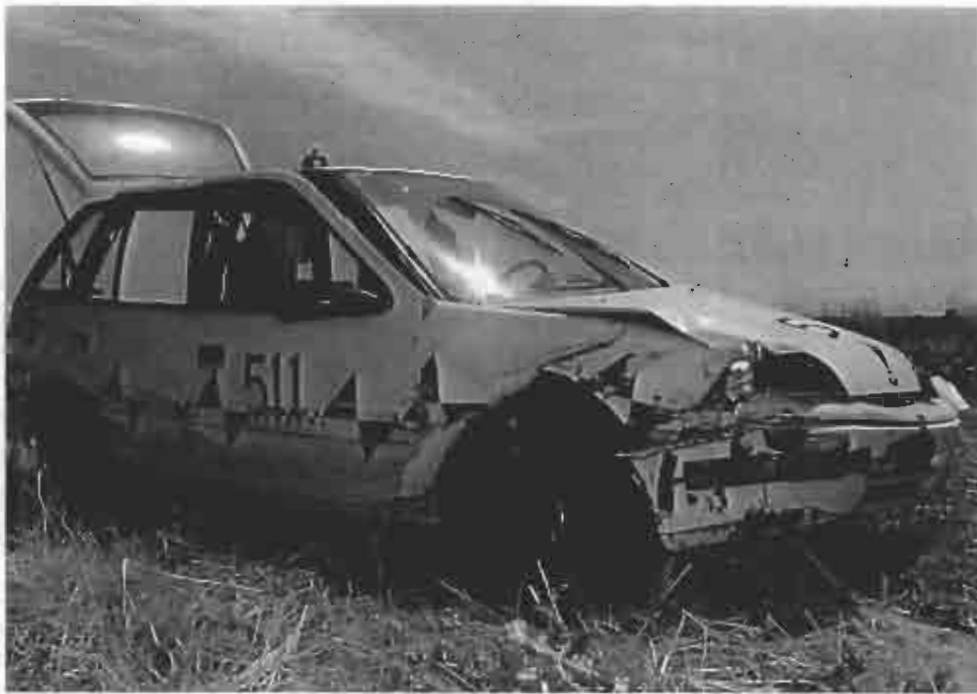
**Figure 2.39 -
Right Front Of
Vehicle 511
After Impact**

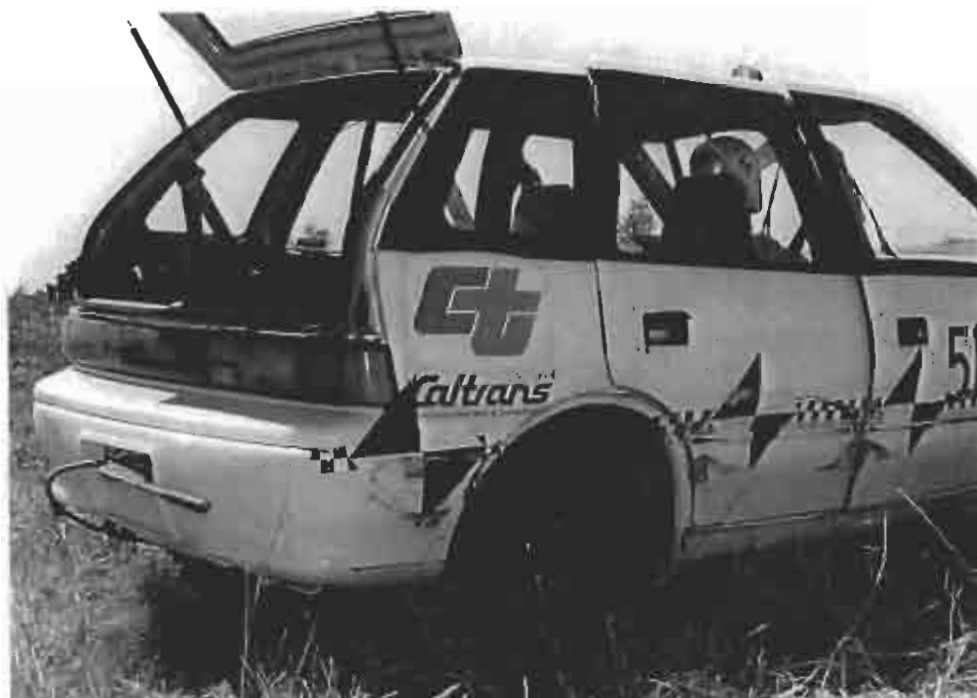
**Figure 2.40 -
Right Rear Of
Vehicle 511
After Impact**

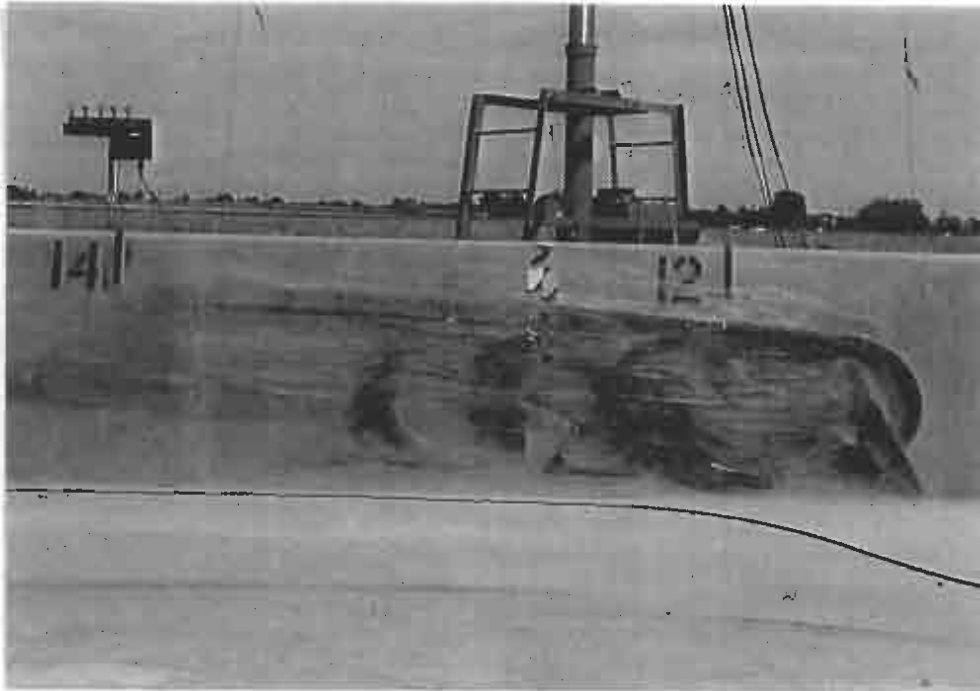
**Figure 2.41 -
Test 511 Impact
Scuff Marks On
The Type 70
Barrier**

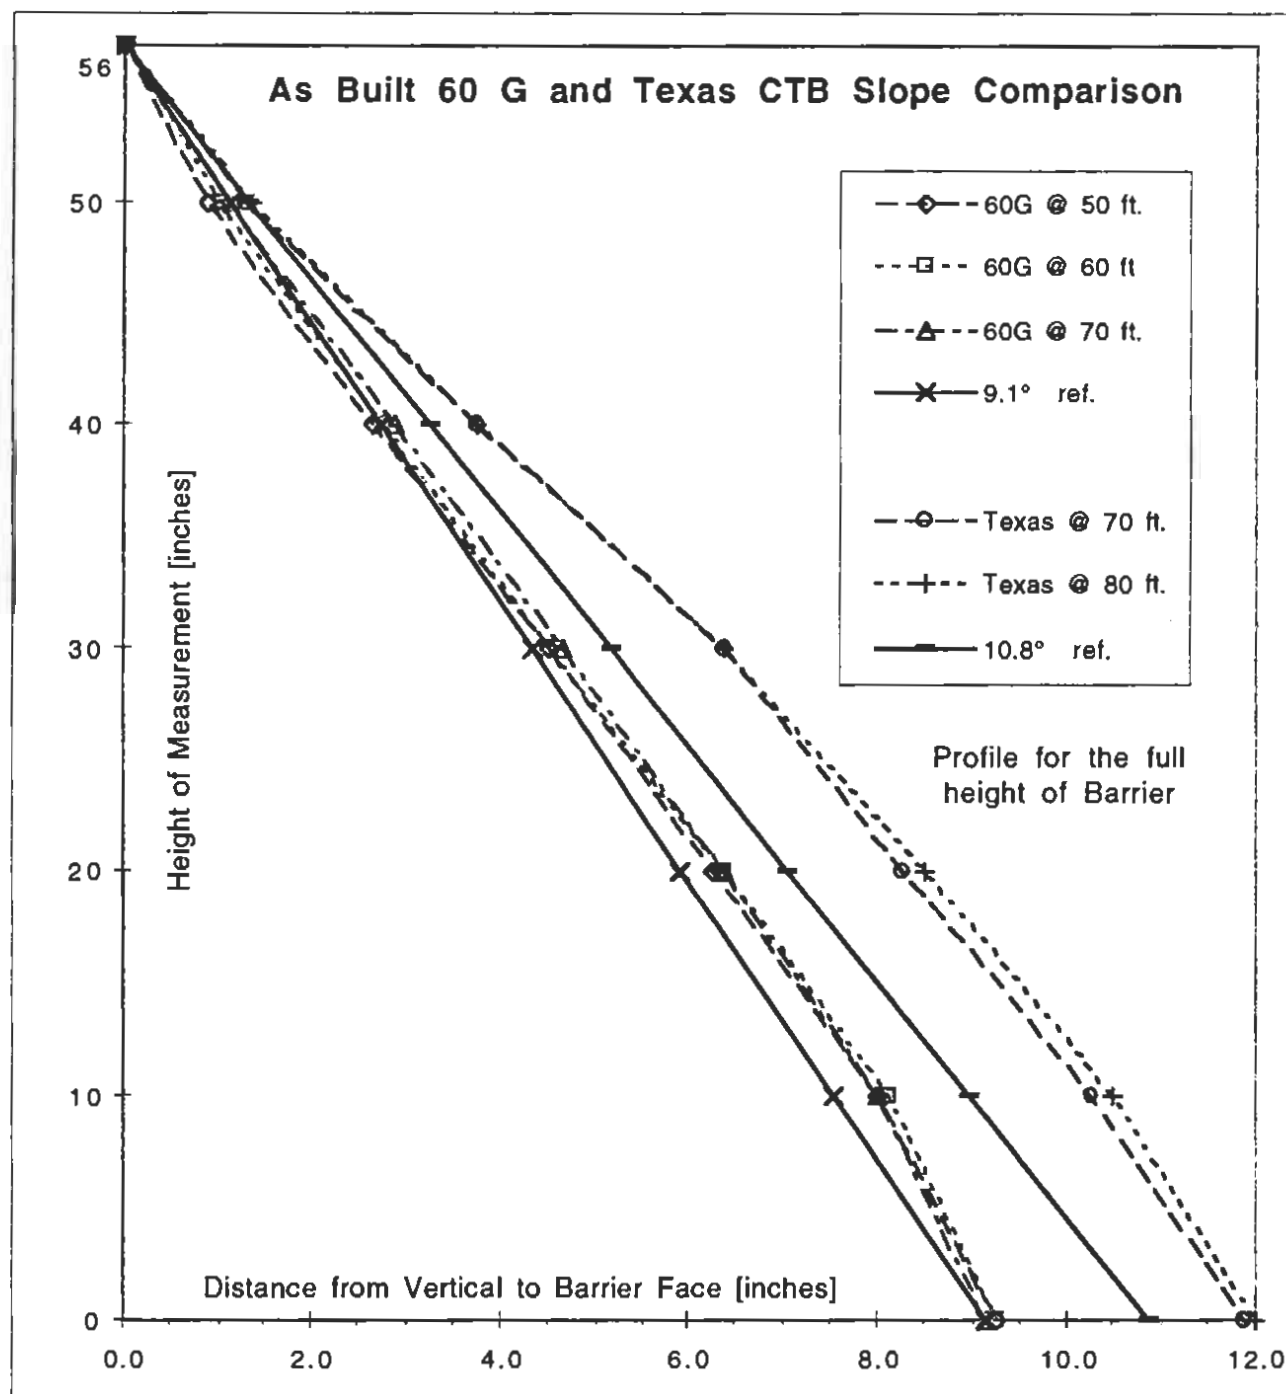
Figure 7.23 - Barrier Profiles, As-Built

After the construction was complete, there was some question as to whether or not the barriers were true to their design profiles (See Appendix 7.6). There were sections that bowed outward from the slumping of the tall barrier. Taking into account the fact that barriers as tall and vertical as these had never been constructed using slip-forming techniques before, it was expected that there would be problems. However, it is also anticipated that these problems will be addressed as contractors gain experience in using the new equipment. Figure 2.3 through Figure 2.10 show the slip-forming equipment and the barrier construction.
